DELAWARE RIVER BASIN
INDIAN RUN, MONMOUTH COUNTY
NEW JERSEY

INDIAN LAKE DAM

NJ 00188

PHASE 1 INSPECTION REPORT NATIONAL DAM SAFETY PROGRAM

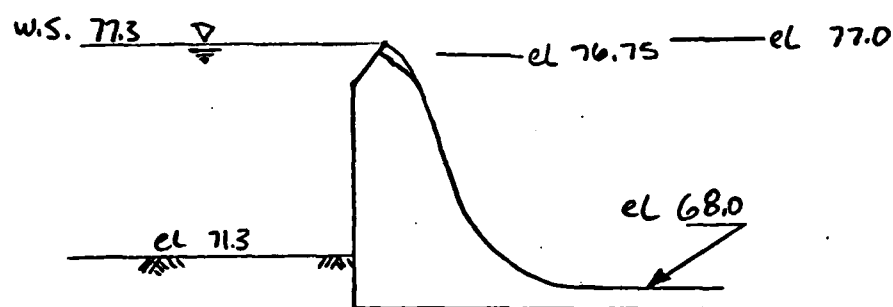
THE SPILLWAY AT THE INDIAN LAKE DAM IS A TWO-STAGE, FREE OVERFLOW, CONCRETE WEIR, WITH A MODIFIED OGEE CROSS SECTION.

THE PRIMARY CREST IS AT ELEVATION 76.75 WITH AN EFFECTIVE LENGTH OF 10 FEET. THE SECONDARY CREST IS AT ELEVATION 77.0 WITH AN EFFECTIVE LENGTH OF 23.8 FEET. DISCHARGE WILL BE CALCULATED USING THE FORMULA; $Q = CLH^{3/2}$

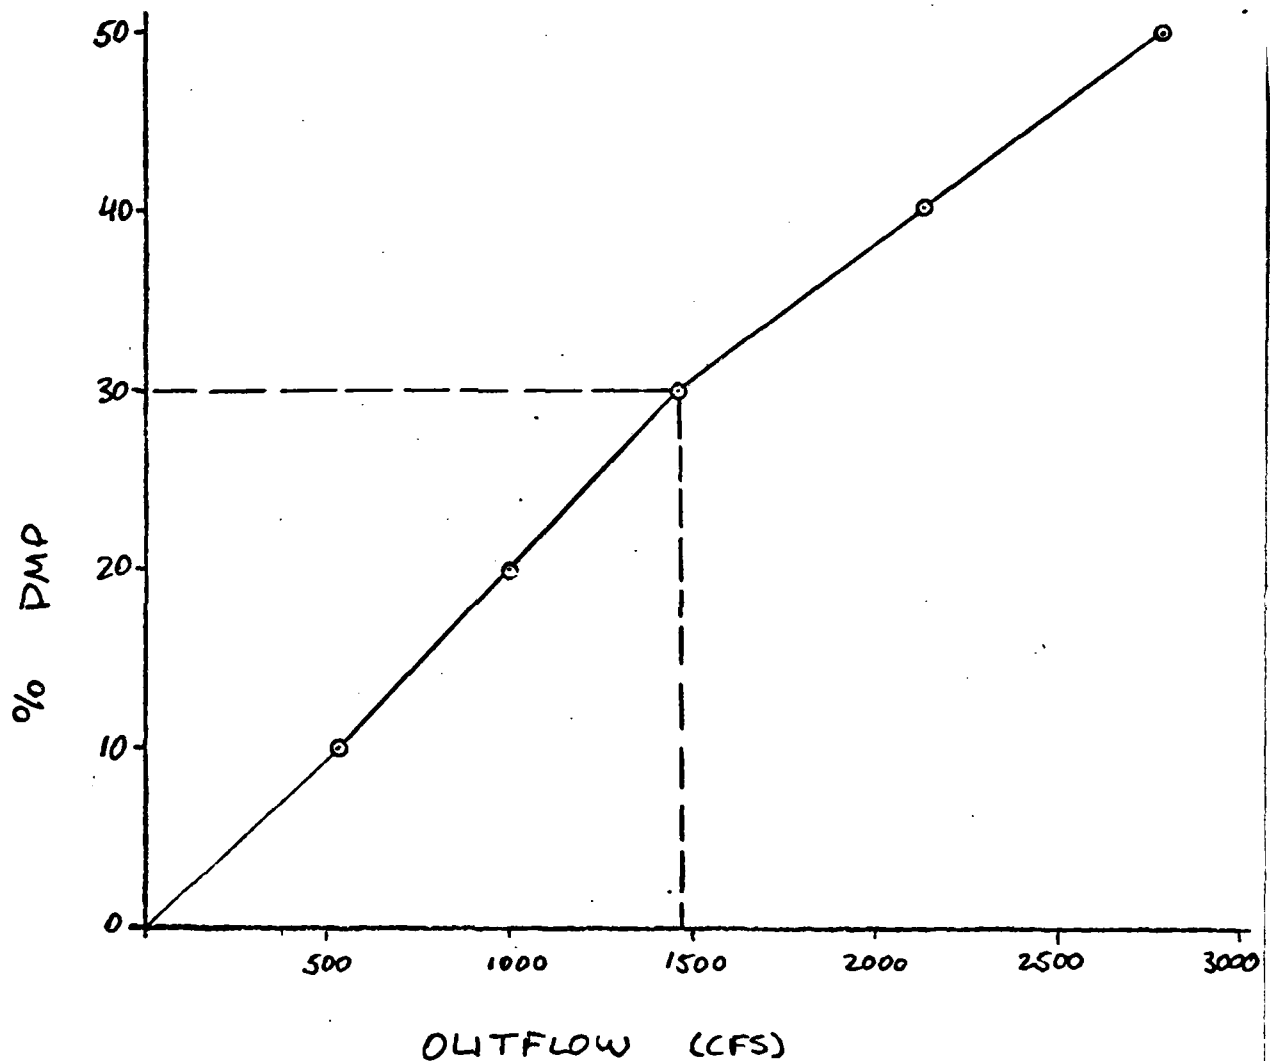
OVERTOPPING POTENTIAL

OVERTOPPING OF THE DAM OCCURS AT
ELEVATION 82.1 WITH $Q = 1472$ CFS \therefore DAM
CAN PASS APPROXIMATELY 30% PMP
OR 60% SDF
